Guide Plug Oil Leak – addendum to repair instructions

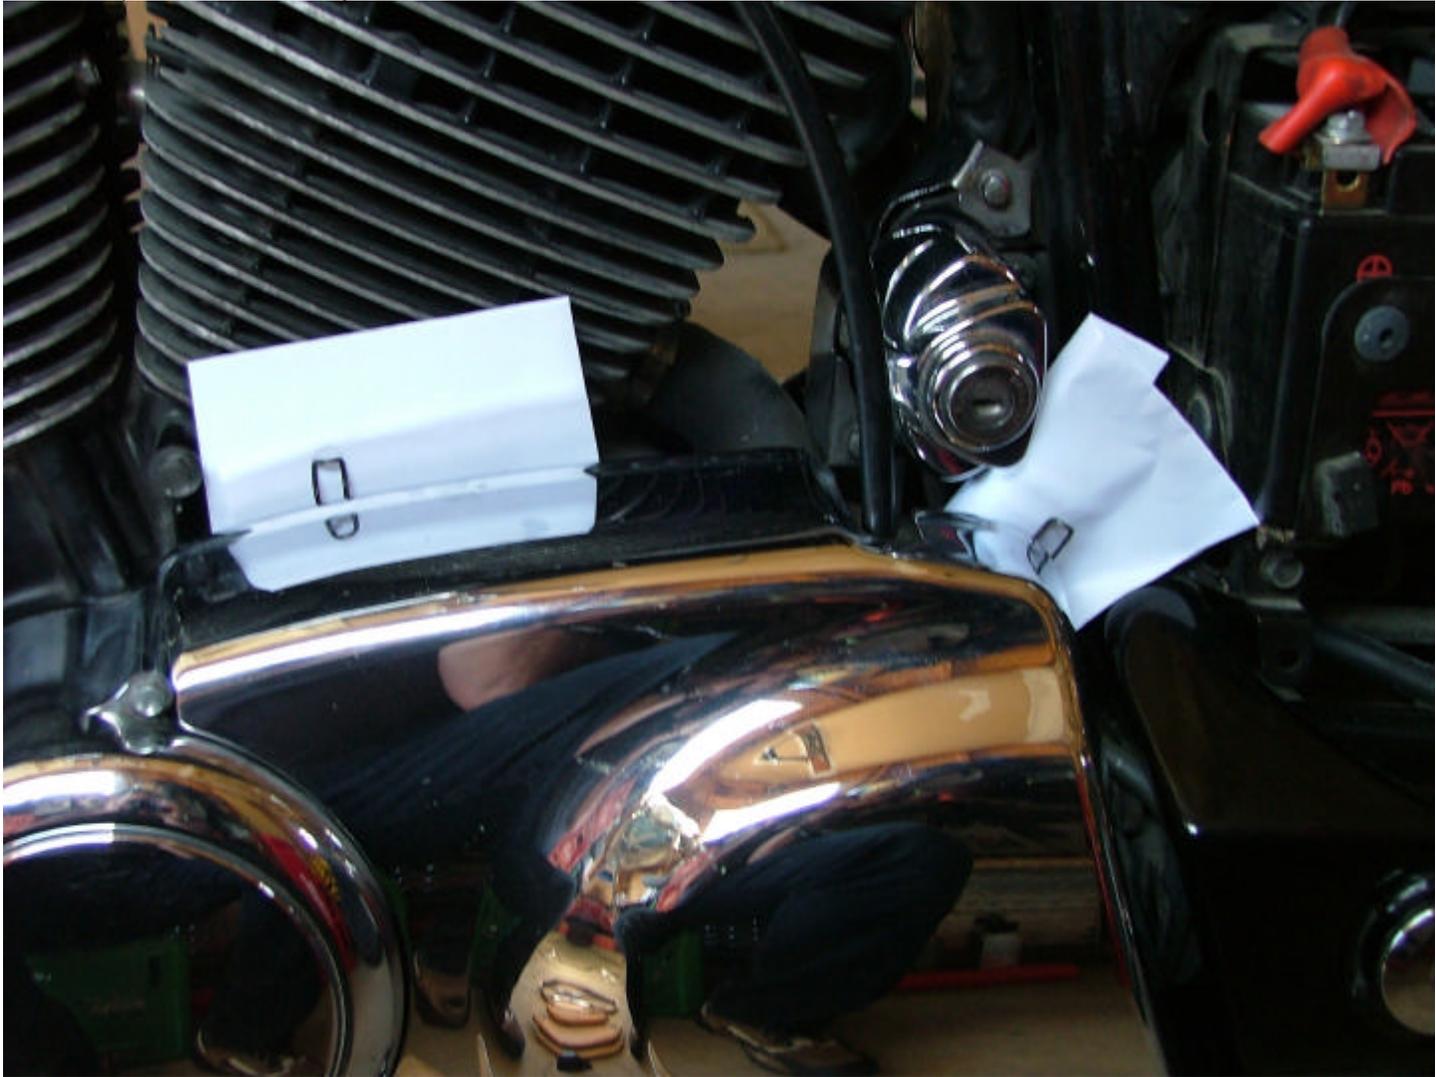
The “dress up to make it look pretty” cover is identified as the left crankcase rear cover in the Service Manual. It is held on by **MORE** than one nut! There are also 2 spring clips (and washers) that hold it on place:

The clips are in front of the pieces of paper – placed to make the clips stand out in the photo. Pull the clips before or after removing the nut. Be careful to retrieve the washers that are between the clips and the rubber grommets.

The retaining nut on the left crankcase rear (“dress up to make it look pretty”) cover should be torqued to 12 N-m/9 lb-ft. Don’t forget the 2 clips AND the 2 washers.

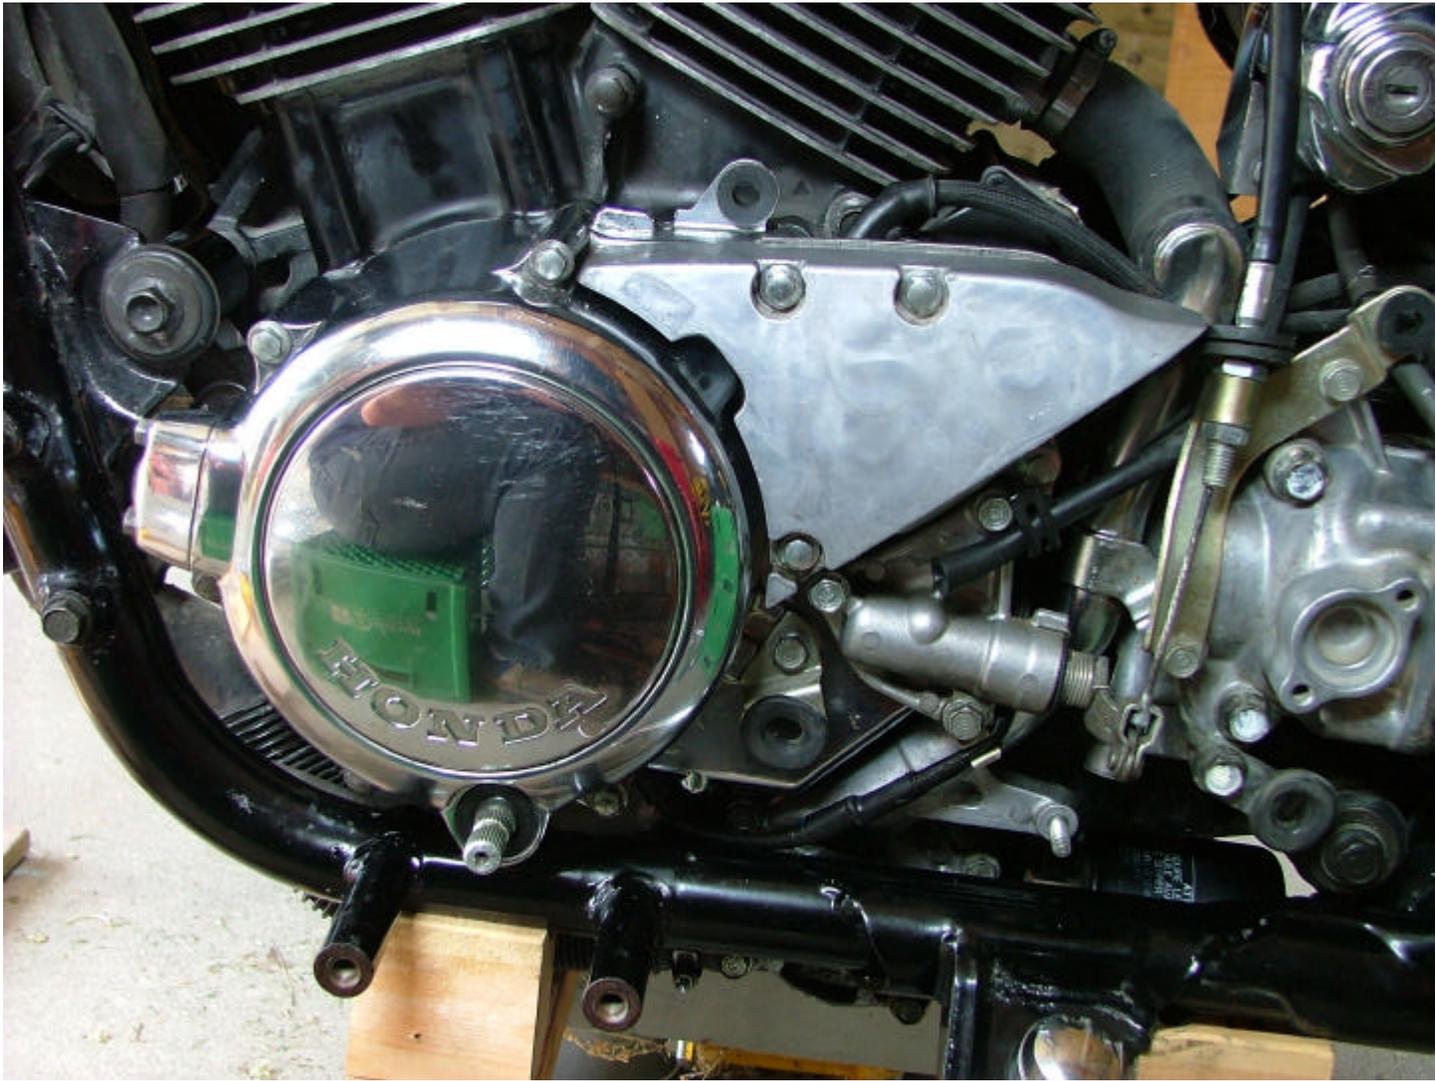
Photo with left crankcase rear cover removed:

After removing the clutch cable, the clutch lifter arm (identified as the “tension assemble” in the repair instructions) should be removed; 2 of the 3 (instructions state only 2) bolts holding it in place go through the crankcase cover. Note the location of the dowel pin.

The lifter rod under the lifter arm should **NOT** be removed. (If it is removed and the orientation is not carefully noted, the correct orientation can be found at the beginning of the clutch installation instructions in the Service Manual.)

The starter gear cover is retained by 4 bolts; (at least) 1 goes through the crankcase cover. Note the locations of the 2 dowel pins.

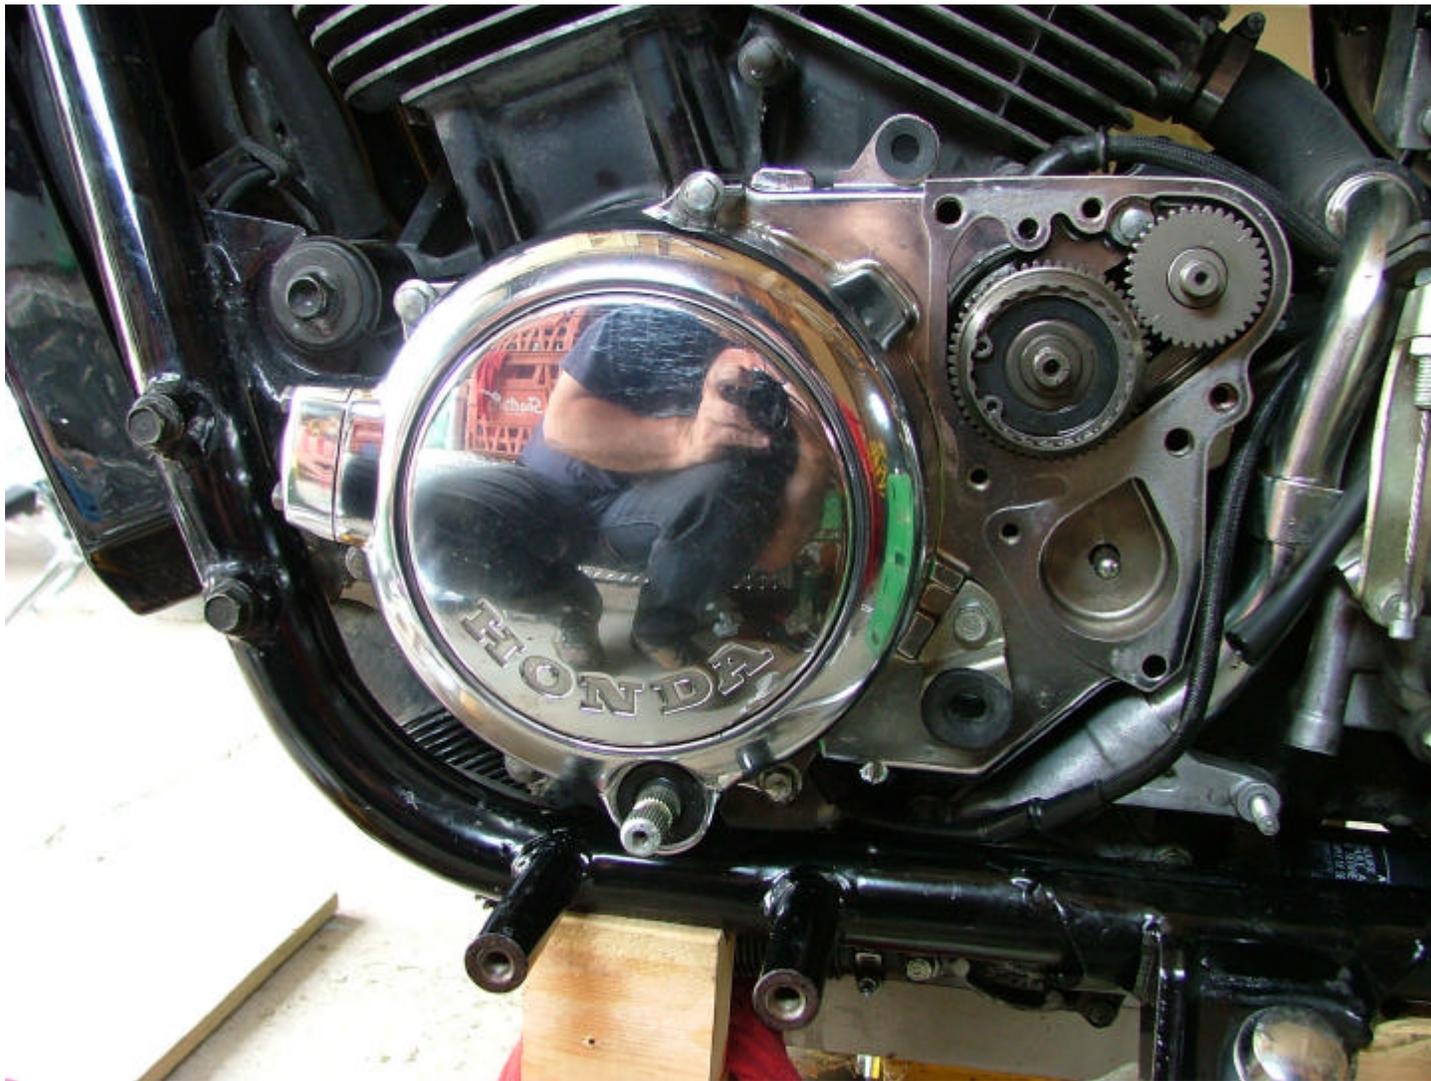
Photo with the clutch lifter arm and the starter gear cover removed:

Note the end of the lifter arm.

The two starter gears (the drive gear on the right and the torque limiter on the left) **must** be removed. I believe that “Wrap both with a rag put a cloth to absorb excess oil – **DON'T** spray them with brake cleaner – the ends must have oil on them or you will have a **LOT** of trouble putting them back in.” is meant to be instructions on these two gears.

There are 7 bolts retaining the crankcase cover at this point, including the “hidden” one. (All seven are visible in the previous photo but the two on the lower left are partially obscured.)

The instructions understate the difficulty of removing the crankcase cover; it will likely be necessary to use a pry bar AND a rubber mallet and take a while and effort to loosen the gasket. The cover will **NOT** move easily even if all the bolts have been removed – at least not at first. But it is **VERY** important to be sure all 7 bolts have been removed!

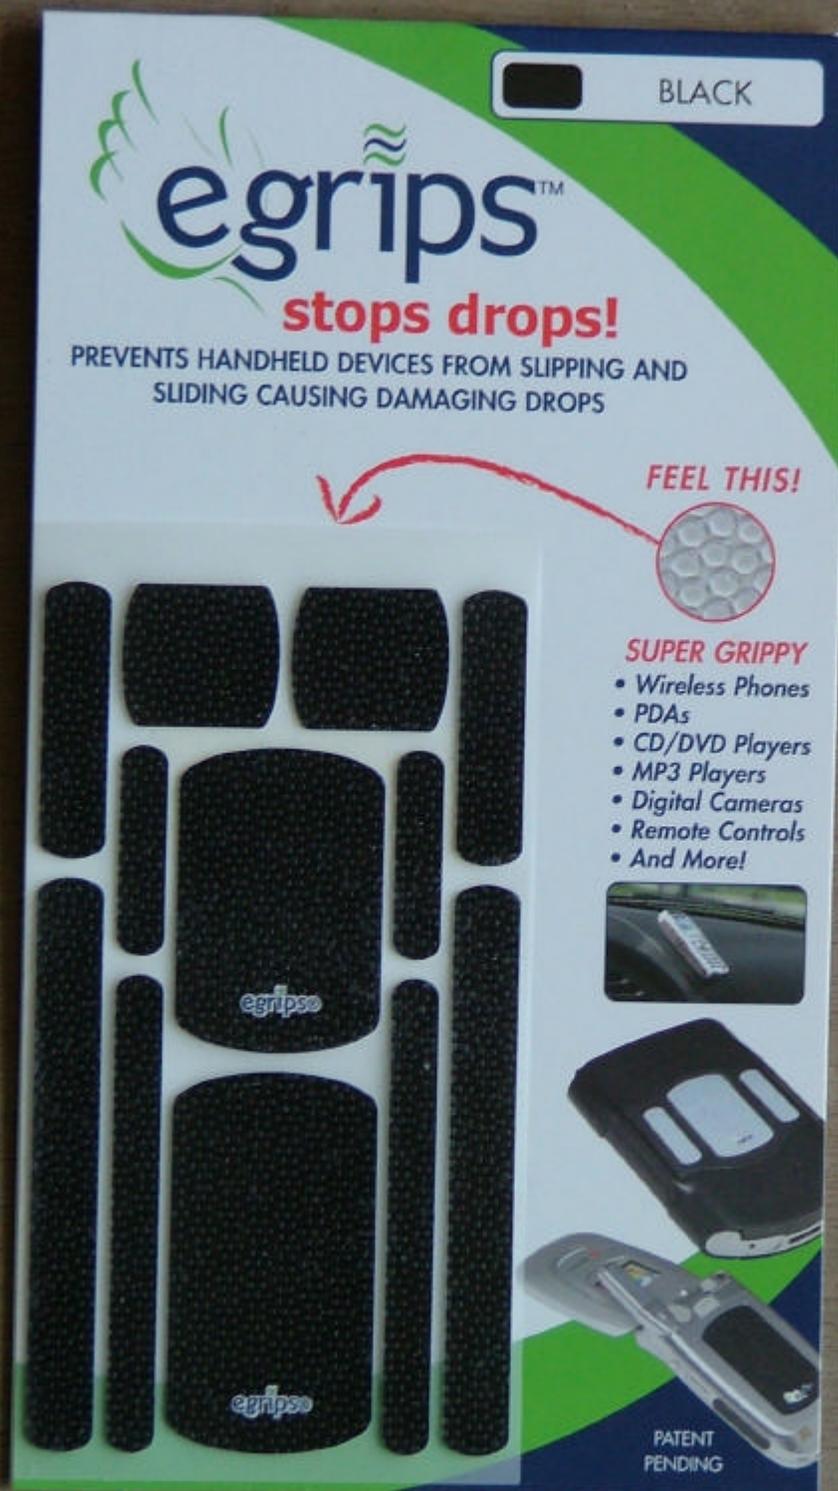
No mention of the cardboard is made after page 3; I believe that this is the appropriate place to insert the instructions – after the “dry fit” trials but before the actual re-assembly. Rather than cardboard, I used a small piece of *egrips*

and used weatherstrip adhesive to attach it to the crankcase cover; time will tell if it can withstand the heat of the engine.

Weatherstrip adhesive seems unnecessary; RTV gasket sealant would seem to be a better choice and will adequately hold the gasket in place.

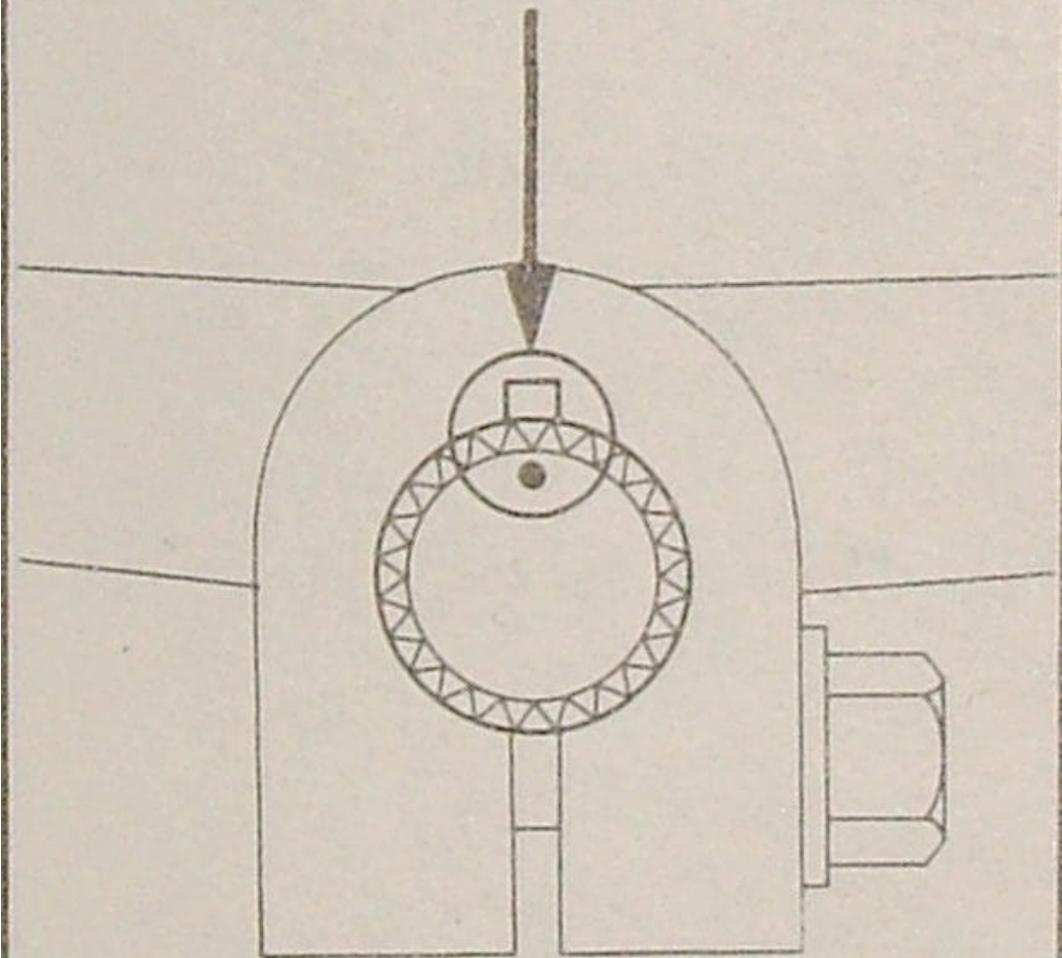
(1) ALIGN

The gearshift lever pinch bolt on my bike should be torqued to 23N-m/17 lb-ft after being aligned correctly. Alignment per the Service Manual:

(My bike has the heel-toe shifter.)
